Release Notes for DrayTek Vigor2862 series (UK/Ireland)

Firmware Version	3.8.8.2_BT (Formal Release)
Release Type	Critical – Upgrade recommended immediately
Build Date	18 th May 2018
Release Date	18 th May 2018
Revision	73942
Applicable Models	Vigor2862, Vigor2862n, Vigor 2862Ln, Vigor2862ac, Vigor 2862Lac, Vigor 2862Vac
VDSL Modem Code	779517
ADSL Modem Code	773F01
Locale	UK & Ireland Only

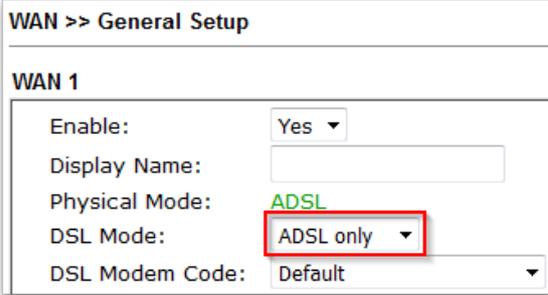
1. If experiencing an issue establishing an Internet connection on ADSL or ADSL2+ connections, set the WAN1 DSL Mode to “ADSL Only”
