## Release Notes for DrayTek Vigor2862 series (UK/Ireland)

Firmware Version	3.8.8_BT (Formal Release)
Release Type	<b>Regular</b> – Upgrade recommended when convenient
Build Date	14 <sup>th</sup> February 2018
Release Date	8 <sup>th</sup> March 2018
Revision	72016
Applicable Models	Vigor2862, Vigor2862n, Vigor 2862Ln, Vigor2862ac, Vigor 2862Lac
VDSL Modem Code	779517
ADSL Modem Code	773F01
Locale	UK & Ireland Only

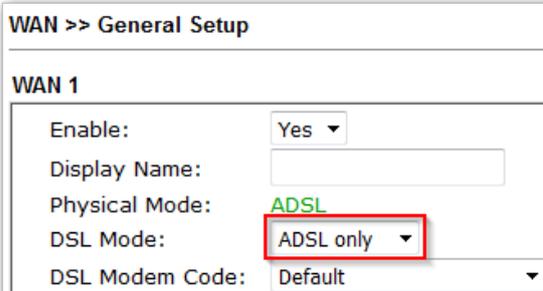
1. If experiencing an issue establishing an Internet connection on ADSL or ADSL2+ connections, set the WAN1 DSL Mode to "ADSL Only"
