## Release Notes for DrayTek Vigor2862 series (UK/Ireland)

Firmware Version	3.9.4_BT (Formal Release)
Release Type	<b>Regular</b> – Upgrade recommended when convenient
Build Date	28 <sup>th</sup> May 2020
Release Date	16 <sup>th</sup> June 2020
Revision	90778
Applicable Models	Vigor2862, Vigor2862n, Vigor 2862Ln, Vigor2862ac, Vigor 2862Lac, Vigor 2862Vac
VDSL Modem Code	779517
ADSL Modem Code	773F01
Locale	UK & Ireland Only

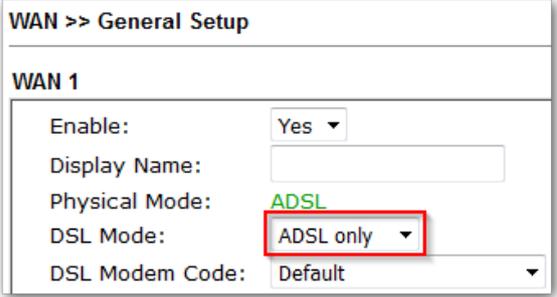
1. If experiencing an issue establishing an Internet connection on ADSL or ADSL2+ connections, set the WAN1 DSL Mode to “ADSL Only”
