Release Notes for DrayTek Vigor2860 series (UK/Ireland)

Firmware Version	3.8.4.4_BT (Formal Release)
Release Type	Regular – Upgrade recommended when convenient Note: A previous firmware (3.8.4.2BT) was a critical release . This f/w includes all changes/improvements that were in 3.8.4.2BT.
Build Date	17 th February 2017
Release Date	23 rd March 2017
Revision	62655
Applicable Models	Vigor2860, Vigor2860n, Vigor2860Vn, Vigor 2860n+, Vigor 2860Vn+ Vigor 2860ac, Vigor 2860Vac, Vigor 2860L, Vigor 2860Ln
Locale	UK & Ireland Only

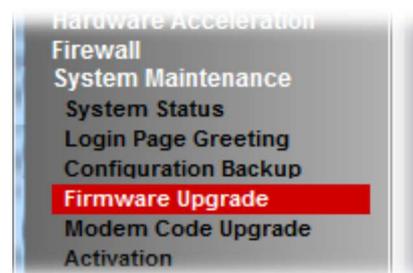
To upgrade firmware, select '*firmware upgrade*' from the router's system maintenance menu and select the correct file. Ensure that you select the ALL file unless you want to wipe out your router's settings back to factory default.

It is recommended that you take a configuration backup prior to upgrading the firmware. This can be done from the router's system maintenance menu.
