Release Notes for DrayTek Vigor 2926 series (UK/Ireland)

Firmware Version	3.8.9.2 (Formal Release)
Release Type	Regular – Upgrade recommended when convenient
Build Date	16 th July 2018
Release Date	10 th August 2018
Revision	75315
Applicable Models	Vigor2926, Vigor2926n, Vigor2926ac
Locale	UK & Ireland Only

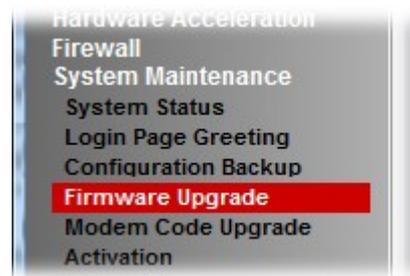
To upgrade firmware, select '*firmware upgrade*' from the router's system maintenance menu and select the correct file. Ensure that you select the ALL file unless you want to wipe out your router's settings back to factory default.
