Release Notes for DrayTek VigorAP 902 (UK/Ireland)

Firmware Version	1.2.0
Release Type	Critical – Upgrade recommended immediately
Release Date	26 th January 2017
Build Date	16 th January 2017
Revision	6740
Applicable Models	VigorAP 902
Locale	UK Only

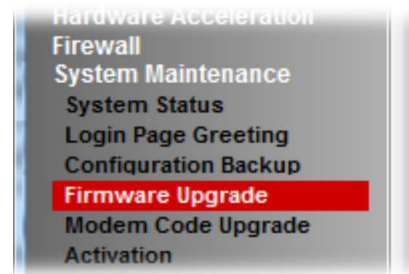
To upgrade firmware, select '*firmware upgrade*' from the AP's system maintenance menu and select the correct file. The access point will perform the upgrade and automatically reboot once this completes.
