Release Notes for DrayTek Vigor2860 series (UK/Ireland)

Firmware Version	3.8.7_BT (Formal Release)
Release Type	Regular – Upgrade recommended when convenient
Build Date	9 th March 2018
Release Date	23 rd March 2018
Revision	72396
Applicable Models	Vigor2860, Vigor2860n, Vigor2860Vn, Vigor 2860n+, Vigor 2860Vn+
	Vigor 2860ac, Vigor 2860Vac, Vigor 2860L, Vigor 2860Ln
Locale	UK & Ireland Only

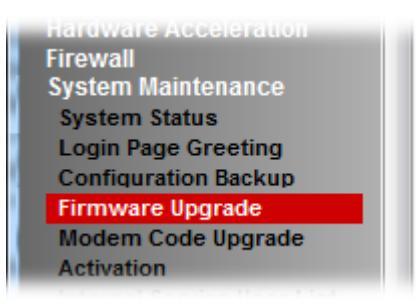
To upgrade firmware, select 'firmware upgrade' from the router's system maintenance menu and select the correct file. Ensure that you select the ALL file <u>unless</u> you want to wipe out your router's settings back to factory default.

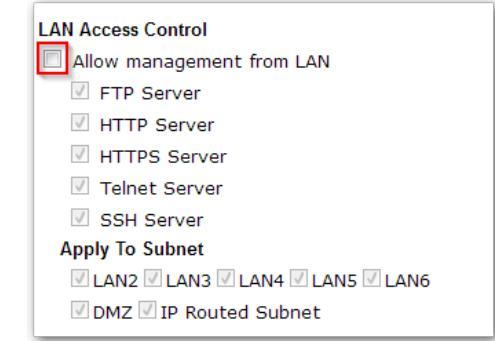
- 1. Configuration issues with Hotspot Web Portal. Do not upgrade to this firmware version if using Hotspot Web Portal, doing so may result in corruption of text / HTML displayed by the web portal. This will be corrected in the next firmware release
- 2. Upgrading a unit which has "Allow Management from LAN" DISABLED as shown in the screenshot, will result in the router's management interface(s) not responding on LAN1 after the upgrade. To avoid this, we recommend enabling "Allow management from LAN" before upgrading the router's firmware to 3.8.5. After upgrade the setting can be set as required and can also be applied to LAN1

In the event that access to management is unavailable on LAN1, either change the LAN Access Control configuration by managing from the Internet, or downgrade to the previous firmware version with the DrayTek Firmware Upgrade utility to regain access via LAN1.
